# Final Addendum 1 to Geotechnical Design Recommendations Report Segments 1 through 6 Feather River West Levee Project

**Project** Feather River West Levee

**Subject** Recommendations for Reach 13  
of the Feather River West Levee Project

This Addendum 1 to the Geotechnical Design Recommendations Report Segments 1 through 6, presents geotechnical considerations for remediation in Reach 13 of the FRWL Project.

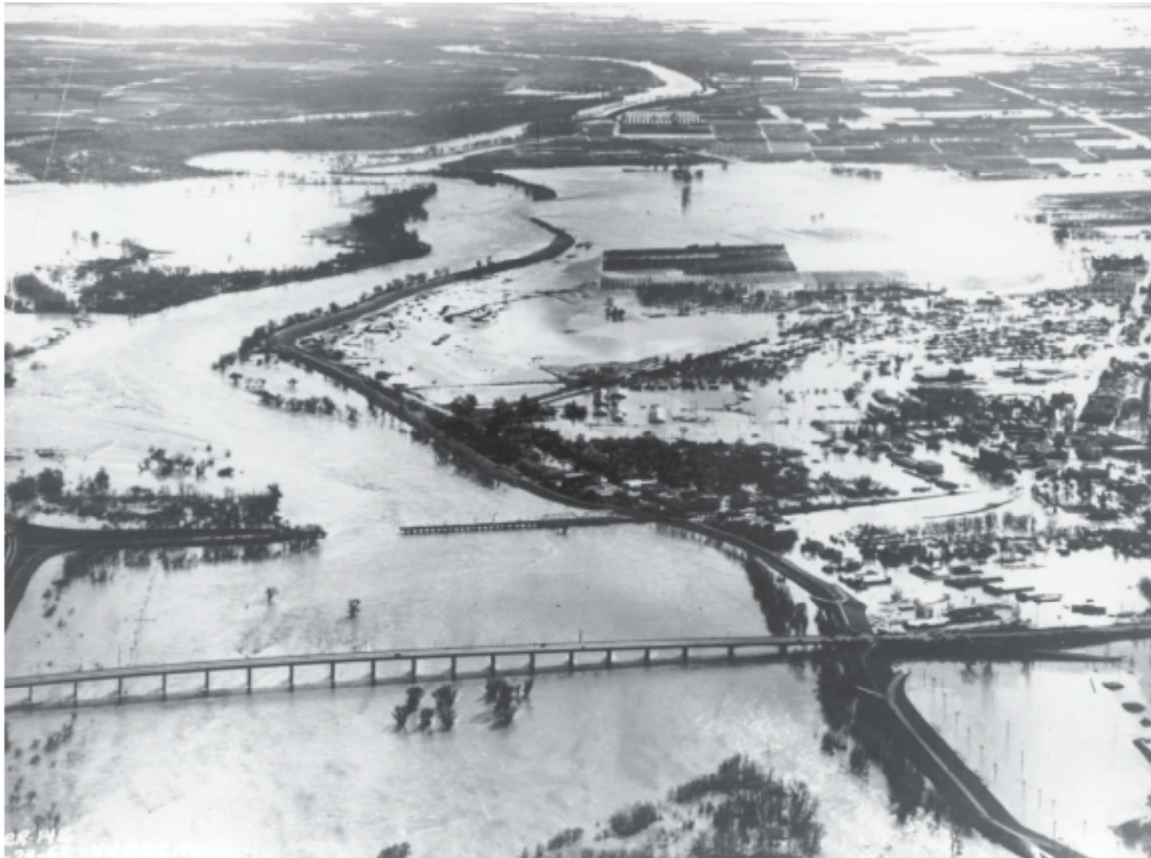
***Figure 1: Photograph of 1955 Levee Break  
with 10<sup>th</sup> Street Bridge in the Foreground  
(Source: Sutter Butte Flood Control Agency Special Publication,  
Flood Aware/Flood Prepare)***

- Levee breaks in 1909, 1911, and 1955. The 1955 levee break is a major levee break in California's history. A grand jury was formed subsequent to the 1955 flood. Based on the "Report of 1955 Sutter County Grand Jury", the following is a summary of the 1955 levee break in Reach 13,
  - The levee break occurred on the west bank of the Feather River at the Gum Tree portion, which is about 2-3/4 miles south of Yuba City (at that time) and approximately 1/4 of a mile north of Shanghai Bend, as shown on Figures 1 and 2.

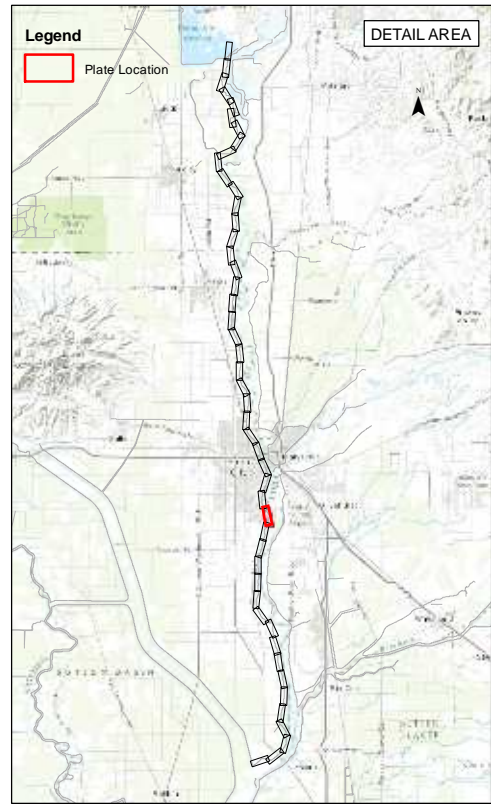
**FRWL Project Plan Views and Stick Log Figures**  
FRWL Project: Station 810+00 to Station 860+00

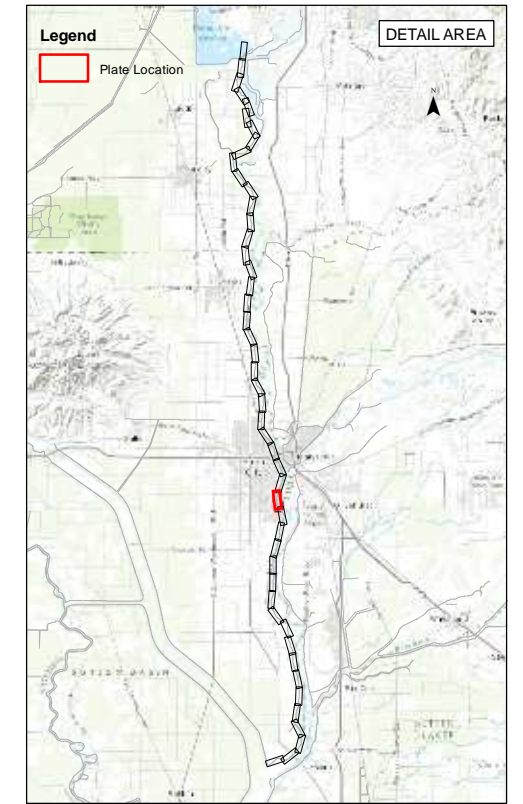
**FRWL Project Plan Views and Stick Log Figures**  
FRWL Project: Station 860+00 to Station 910+00

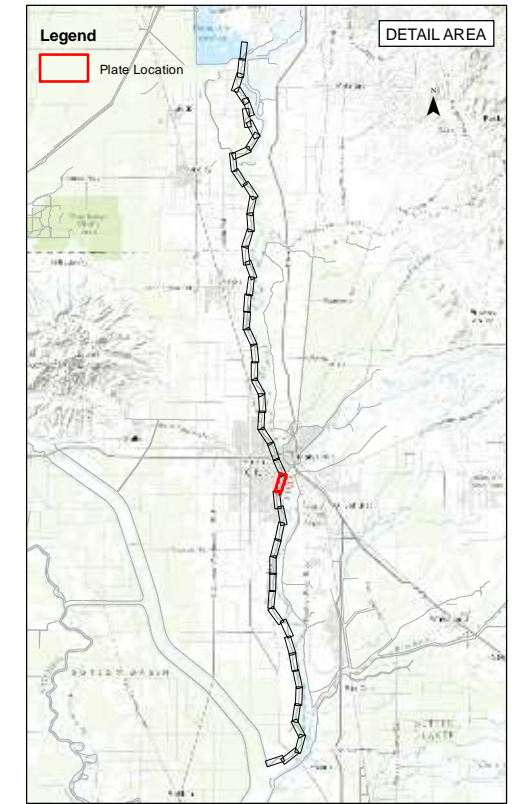
**FRWL Project Plan Views and Stick Log Figures**  
FRWL Project: Station 910+00 to Station 960+00
